Watershed Survey Data Sheet - Gun River Watershed

Gun River Watershed

Prepared for the Gun River Watershed Management Plan

Allegan Conservation District
Allegan County, Michigan
Gun River Watershed Management Plan

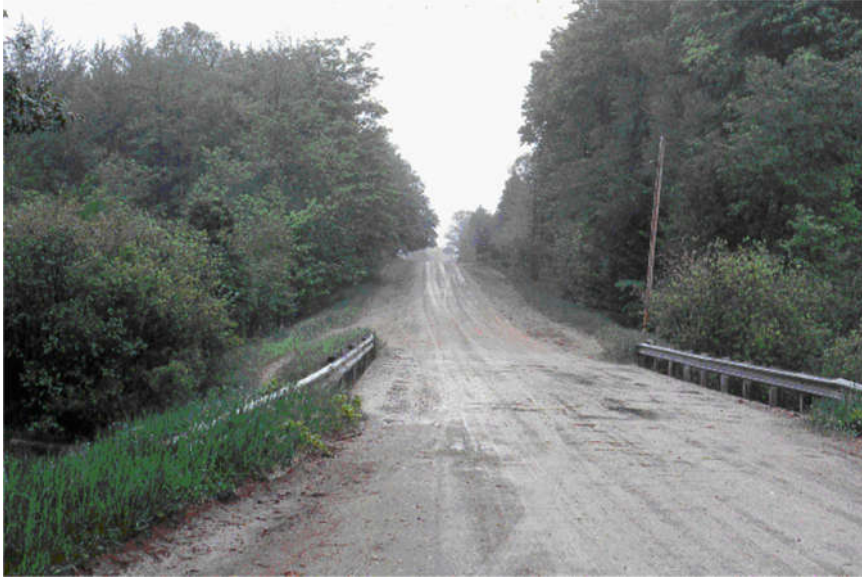
Figure 1. Runoff from steep approaches on dirt roads can cause large amounts of sediment to enter watercourses during rain or snow melt.

Approach material/slope/length: The approach refers to the section of road that slopes toward the crossing (Figure 1). Record the approach material (it is assumed that the left and right approaches are the same material). Determine the slope for the left and right approach (facing downstream). Measure the length of the left and right approach from the middle of the road stream crossing to the top of the slope leading down towards the structure. This is the distance the water would drain down the road to the structure.

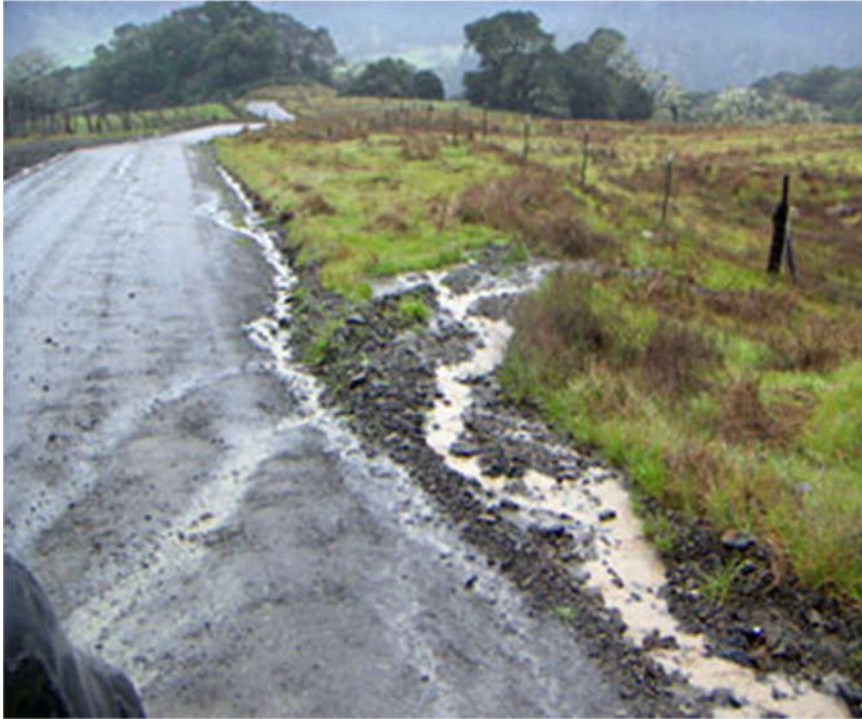
Figure 3. Road runoff has the potential to increase the amount of nonpoint source pollution that enters water bodies.

A road running parallel to (or close to) a water body would be the first indication that road runoff may be a potential pollutant source. A visual cue that it is a source would be rills (see definition page 8) running from the road surface (Figure 3 and Figure 4a).

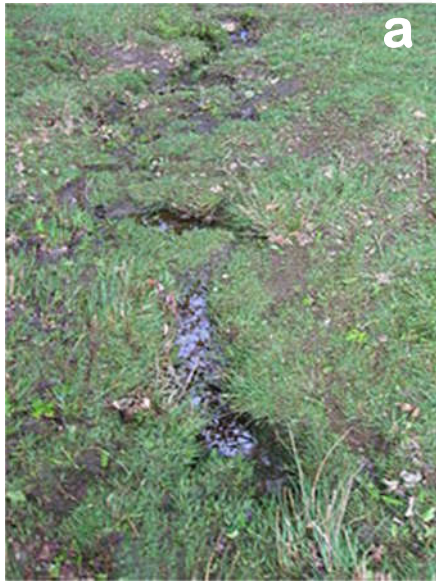
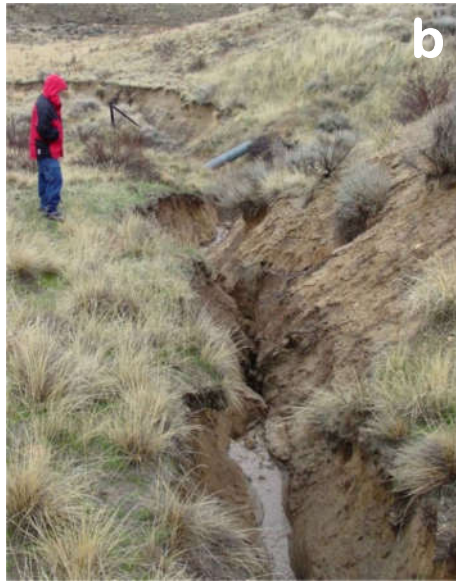
Figure 4. An example of a rill (a) compared to the size of a gully (b).

Erosion type (select all that apply): If you observe livestock access, but no erosion, then circle “none” for the erosion type. If you observe erosion, determine if the type of erosion is a rill, streambank, or gully (can circle more than one category if applicable). A rill is the initial sign of erosion and is most common on slopes. Rills are much smaller than a gully (Figure 4a). Determine if the rill exhibits minor, moderate, or severe erosion. For streambank erosion that is a direct result of livestock access, measure the height and length of the eroding bank and determine the erosion severity (Remember, if the streambank erosion is not associated with livestock access, then it would fall under SECTION 4. STREAMBANK EROSION, not SECTION 5. LIVESTOCK ACCESS). A gully erodes sharply into the soil and it is often difficult to step across (Figure 4b). Measure the top/bottom erosion width, depth, and length.

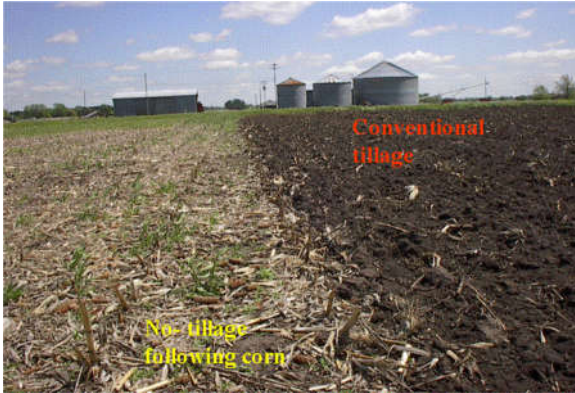
General photo depicting a side-by-side comparison of a no-till field versus conventional tillage practices.

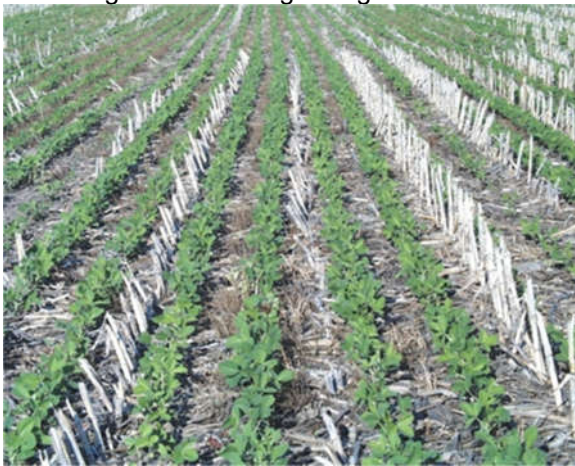
No-till fields: crops are planted without disturbing the soil through tillage

No-till soybeans planted in corn residue.

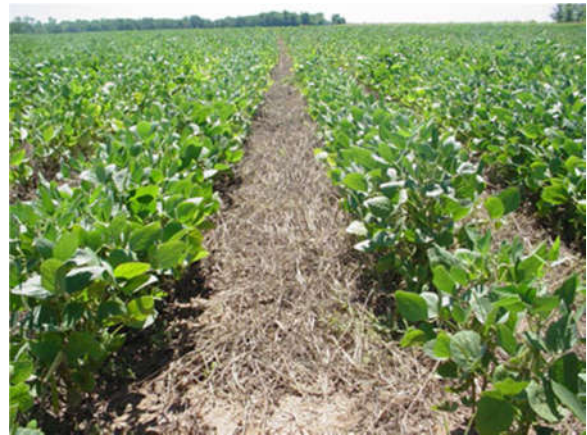
No-till soybeans growing in wheat residue.

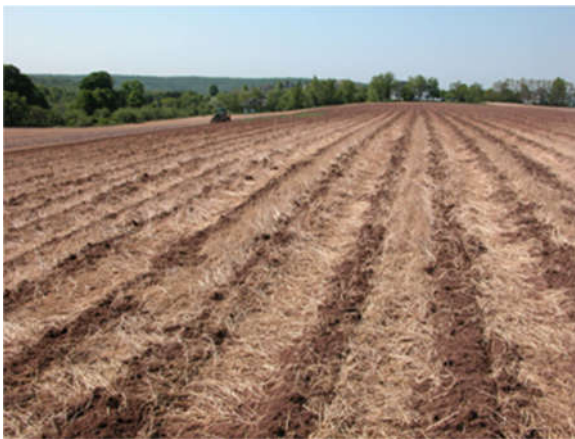
Strip tillage (falls into no-till category): a form of tillage where only narrow strips are tilled

Strip tillage was used to prepare this field for corn planting.

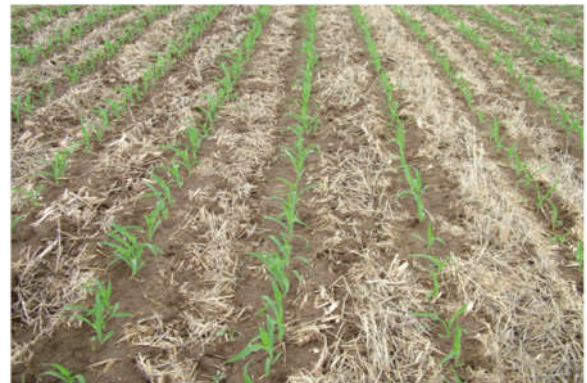
Strip tilled corn planted in wheat residue.

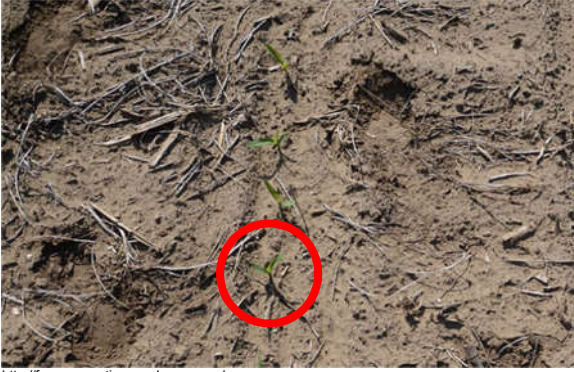
Reduced tillage: method of soil tillage which leaves at least 30% crop residue on the soil surface

After planting – corn (circled in red) growing after being planted into 30% soybean residue.

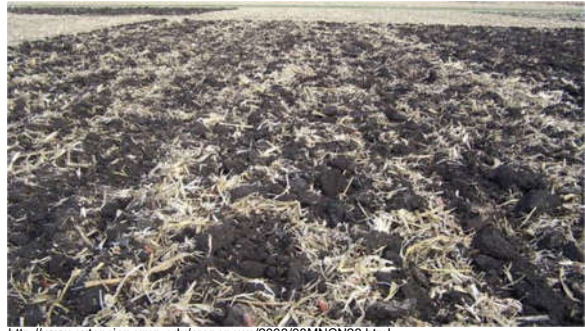
Before planting – surface residue coverage after stalk chopping and chisel plowing in a field of corn residue.

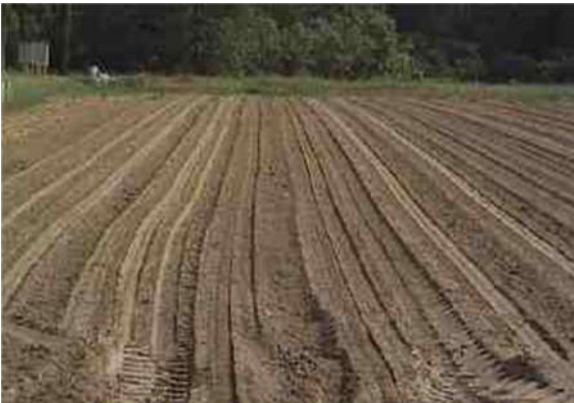
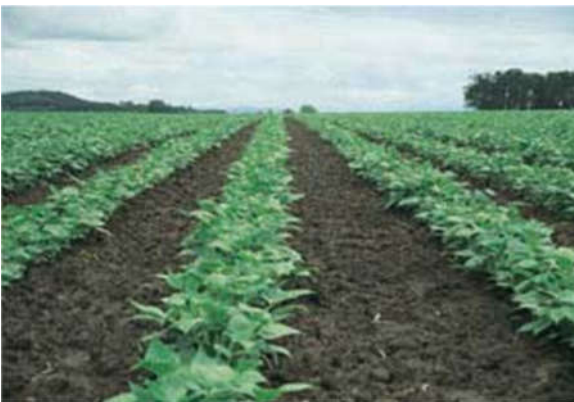
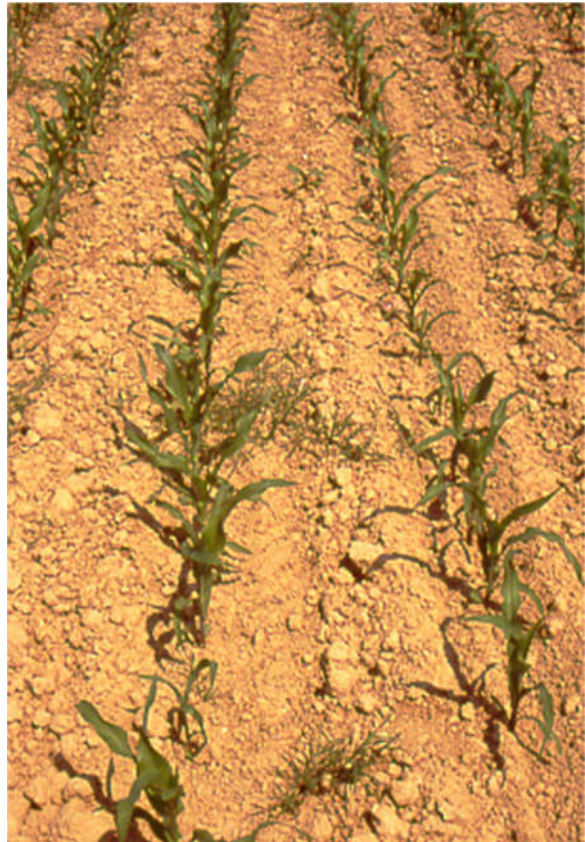
Figure 5. Tillage practices vary in the amount of crop residue left on the field.

Conventional tillage: the traditional method of farming in which the soil is prepared for planting by tillage practices that result in less than 30% residue cover
